**123 Main Street
Anytown PA 18020**

**Client(s): Doe
Inspection Date: 3/26/2016**

1. Septic System

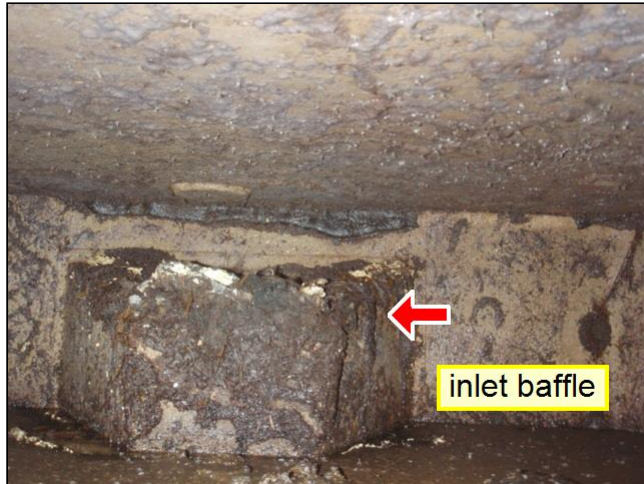
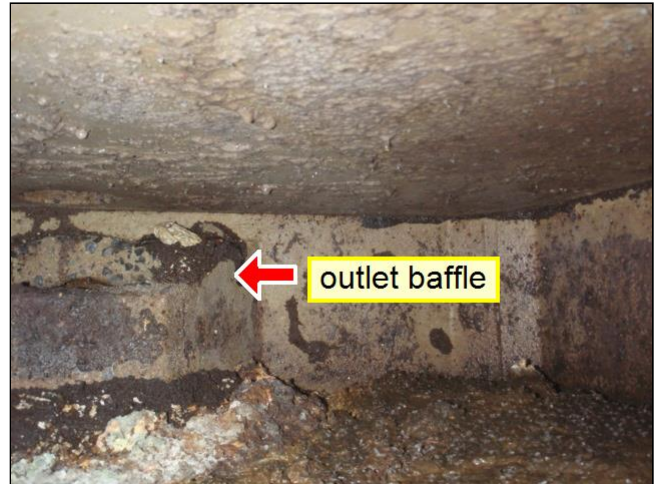
VISIBLE INSPECTION OF INSIDE TANK

- ◆ The visible and accessible areas of the treatment tank inlet baffle appeared to be in serviceable condition at the time of the inspection.

The visible and accessible areas of the treatment tank outlet baffle appeared to be in serviceable condition at the time of the inspection.

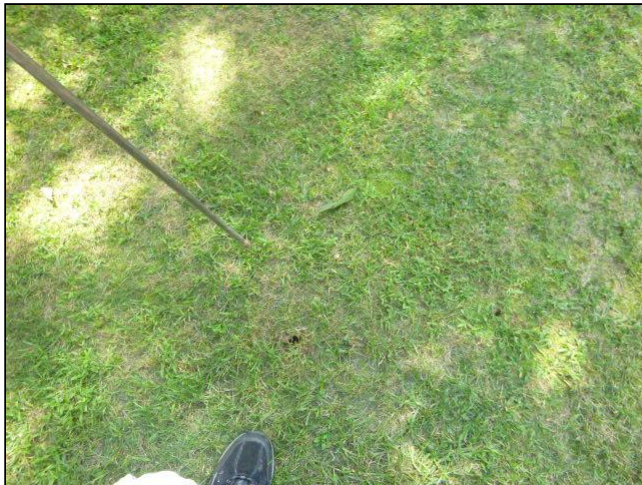
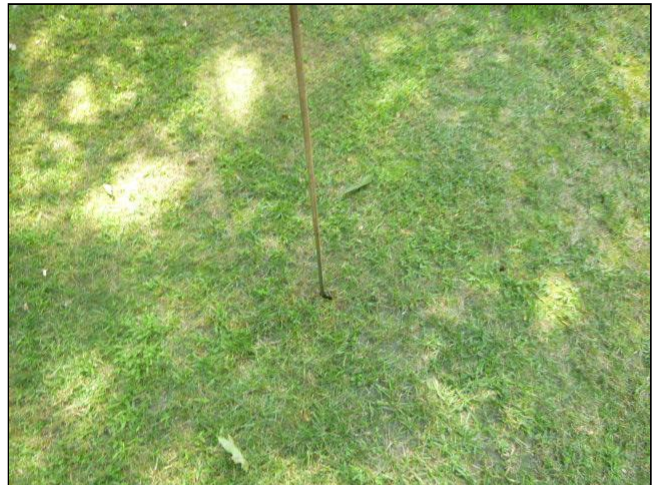
ABSORPTION AREA

- ◆ The absorption area appeared to be in serviceable condition at the time of the inspection.

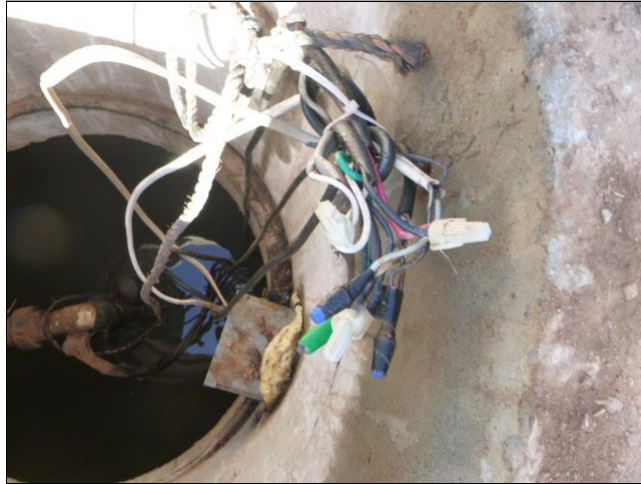
DOSING TANK, PUMP AND ALARM

- ☒ ◆ The wiring to or in the dosing tank should be improved. Wiring should be in a watertight box, with sealed connections.
